The use of thermal mapping in evaluation of mechanically induced electrical degradation of graphene - based transparent heaters

Anna Kozłowska¹, Grzegorz Gawlik¹, Anna Piątkowska¹, Aleksandra Krajewska¹, Wawrzyniec Kaszub¹

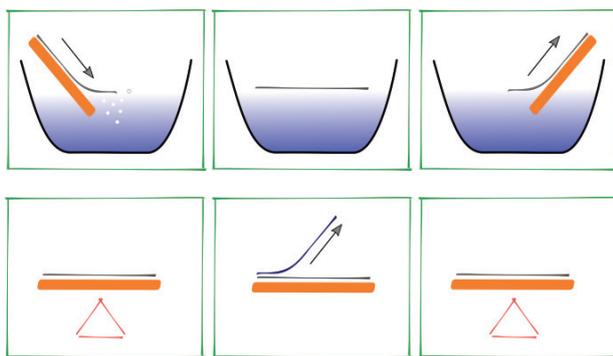
Fig. 1. Essential steps in the process of graphene transfer (from left to right): electrochemical delamination, cleaning process, covering graphene with PMMA on isolating surface, hot-plate, PMMA removing, hot plate.

After the growth, the graphene on Cu foil was covered with a thin layer of poly (methyl-methacrylate) (PMMA) by a spin-coating method. This procedure prevents graphene film from destruction during the electrochemical delamination. A simplified scheme of this procedure is presented in the Fig. 1. After the electrochemical delamination, graphene with PMMA must be cleaned (RCA ceaning method) in deionized water and finally its covering dedicated substrate. Before removing PMMA, the samples were heated up to 120°C in a n air atmosphere. In the final step PMMA was removed into acetone and the sample was heated up once again up to 125°C. To characterize the graphene transferred onto the substrate, we performed

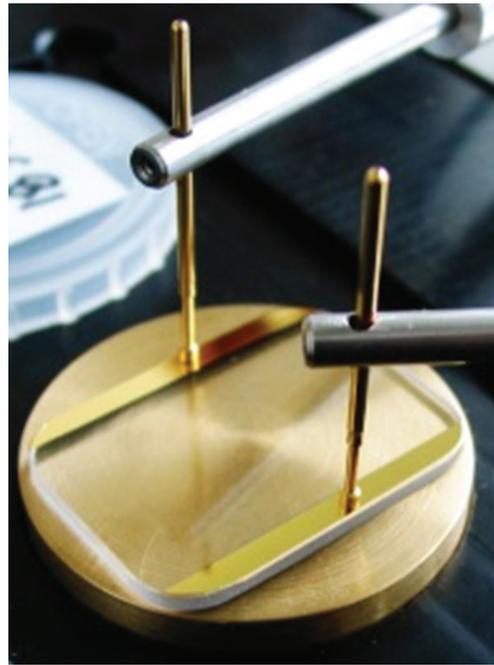
Fig. 2. Photograph of graphene-based heater deposited on glass plate.

Ohmic contacts to graphene were formed using silver conductive paste. A photograph of an exemplary graphene-based transparent heater is shown in Fig. 2. The size of the sample was 25 mm x 20 mm. The tribological system consisted of a ball on a flat surface with normal load of 0.8 N. The counterpiece was formed by a ceramic ZrO_2 ball with a diameter of 2 mm. The one-stroke mode was applied in tribological tests for a better observation of the graphene wear phenomena. Several graphene discontinuities could be observed on the graphene surface. The position of these scratches on the sample is schematically shown in Fig. 3a.

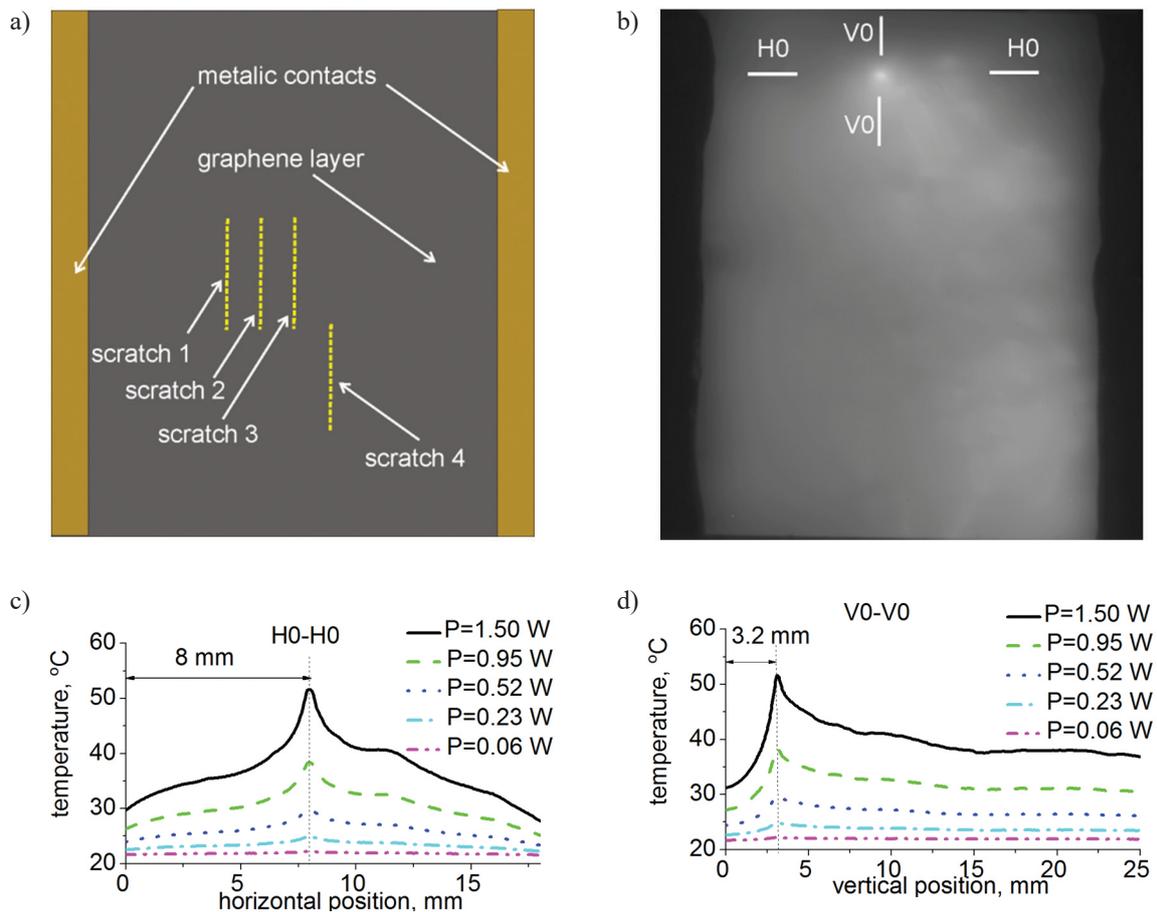
Fig. 3. Schematic of the sample and the results of the thermographic characterization of pristine CVD graphene sample. a) Drawing of the sample with the marked position of intentional scratches. b) Thermal image for a pristine sample biased with $I = 30$ mA and $U = 50$ V. c, d) Horizontal and vertical cross-sections through a hot spot for five supply power levels, respectively.

The results of the thermographic characterization for a pristine, Joule-heated sample are presented in Fig. 3b-d. During the test, thermal maps were registered for the currents (I) ranging from 5.7 to 30.0 mA and the voltages (U) ranging from 10 to 50 V, resulting in the power surface density from 0.0114 W/cm² to 0.3 W/cm². An exemplary steady-state thermal map captured for $I = 30$ mA and $U = 50$ V is shown in Fig. 3b. It reveals the areas of elevated temperature located in the middle and the side part of the sample. In the upper part of the image, a distinct hot spot can be observed. Horizontal and vertical cross-sections through this hot spot for different supplied power levels are shown in Fig. 3c and Fig. 3d, respectively.

In the next step, as shown in the scheme in Fig. 3a, four scratches were made on the sample using the tribological system described in the previous section. SEM observa-

the uniformity of the resulting thermal distributions. Typically, a crack starting from the border of the sample gives a Joule heating distribution in the form of a single hot spot, whereas rectangular defects result in two hot areas at the ends of the crack [7]. These effects can be observed in Fig. 3b, Fig. 5a, and 6a. A more complicated pattern is revealed at horizontal cross-sections H2-H2 shown in Fig. 3b and 4b, where an additional maximum can be observed. A microscopic observation shows that scratch 3, presented schematically in Fig. 3a as a straight line, in practical realization forms a small zig-zag at one end. Apart from the distinct hot-spots, thermal images show overall uniform deterioration, which is probably due to layer defects such as graphene wrinkles [6], which can be frequently observed in the SEM inspection.

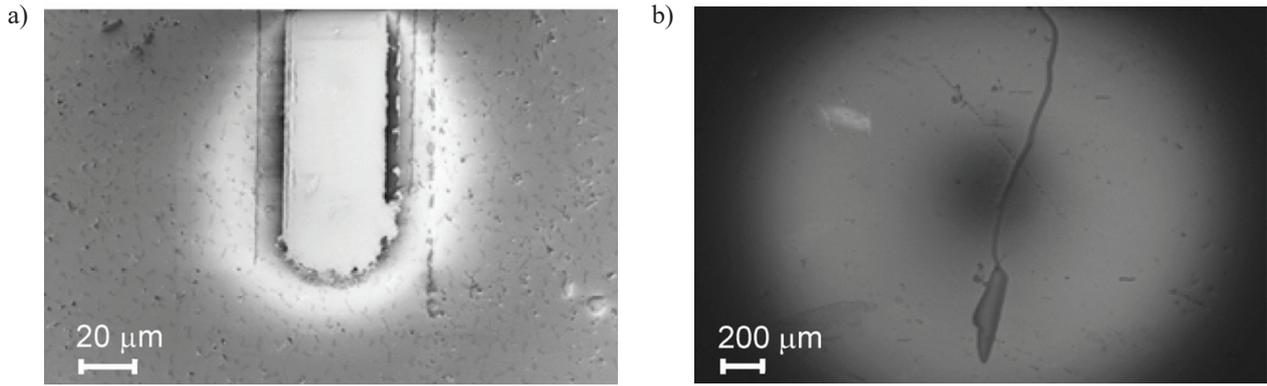
Fig. 4. SEM photographs of the graphene sample. a) Ending point of a scratch produced by nanoscratch method. b) Accidental defect on a graphene sample.

A SEM photograph of the tip of one of the scratches is presented in Fig. 4a. Apart from intentionally introduced cracks, observations of the sample indicate various defects such as the cracks, graphene discontinuities and wrinkles. Particularly, an ending point of a defect starting from the sample border can be observed at the position of the hot spot in the upper part of the sample (Fig. 4b). The sample with intentionally and accidentally introduced scratches was again characterized using the infrared imaging method. A thermal image captured for $U = 50$ V is shown

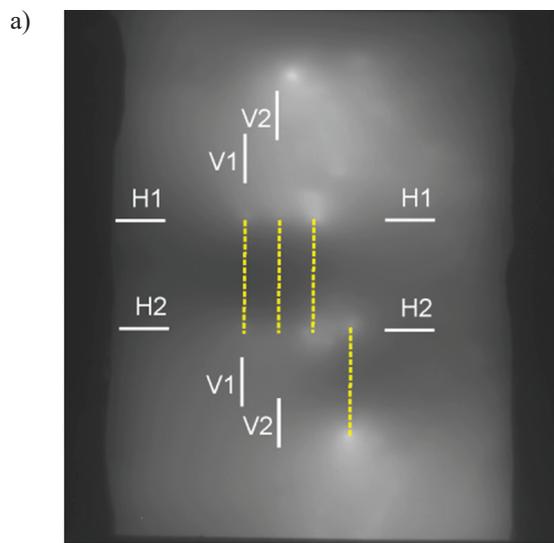
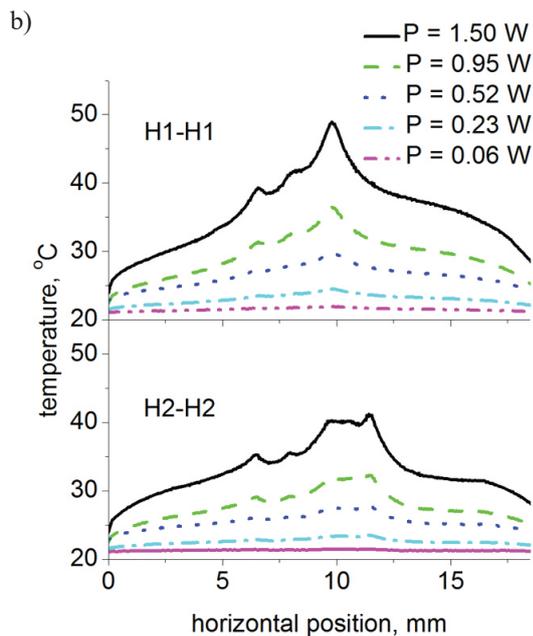
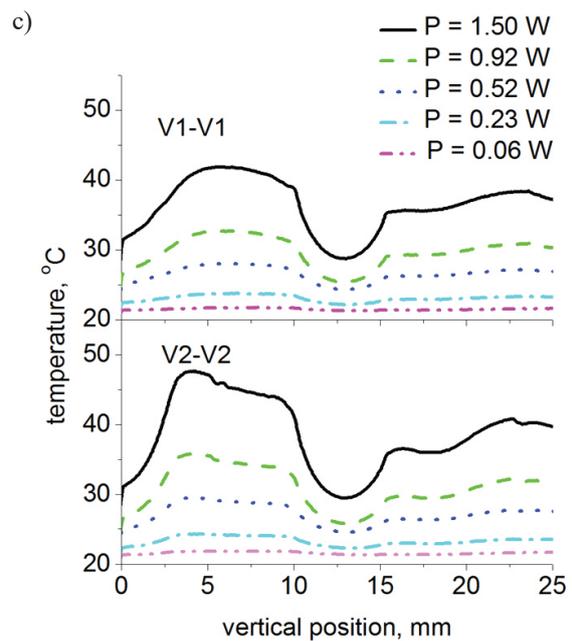
Fig. 5. Results of thermal characterization of graphene sample with intentionally introduced discontinuities. a) Thermal image for sample biased with $U = 50$ V (the position of scratches is marked with yellow dotted lines); b, c) horizontal and vertical cross-sections at marked positions, respectively.

in Fig. 5a. For clarity, the positions of the scratches are marked with the dotted lines.

Horizontal cross-sections at the marked position H1-H1 and H2-H2 for five power supply levels are shown in Fig. 5b. We can see local maxima at the positions of the scratch tips. In contrast, it becomes apparent that at the horizontal cross-section H2-H2, apart from local maxima that correspond to the starting points of scratches 1, 2, 3, and ending point of scratch 4, there is a smaller peak (at horizontal position 10.6 mm). Vertical cross-sections V1-V1 taken along scratch 1 (Fig. 5c) reveal the temperature decrease along at the scratched area and a small temperature increase at the scratch end. This effect can be observed at the cross-section V2-V2 taken along scratch 2. Here additionally, we can observe local maximum at the position 4 mm; this maximum is due to the hot spot in the upper part of the image.

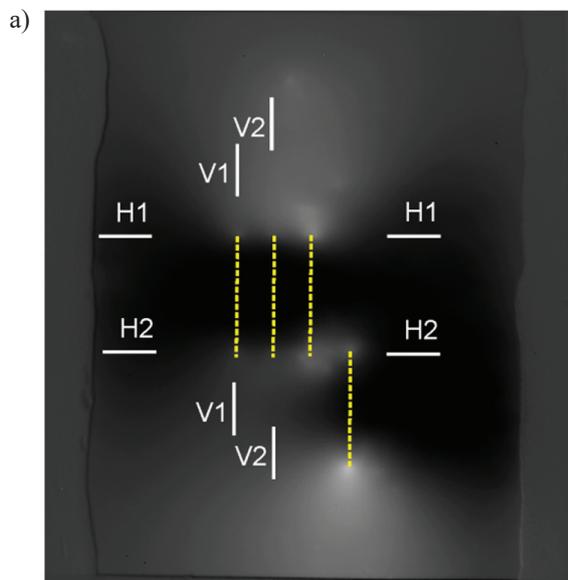
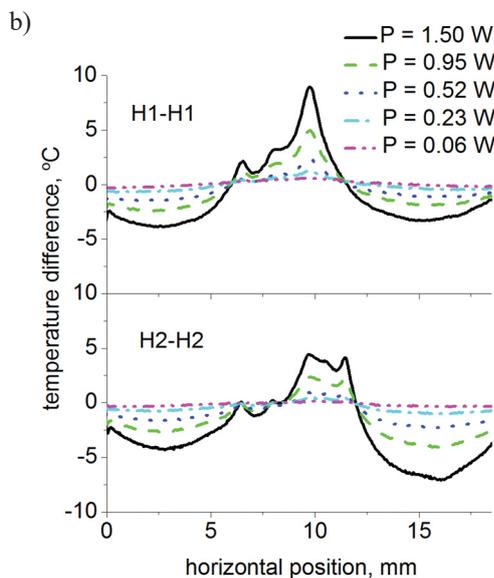
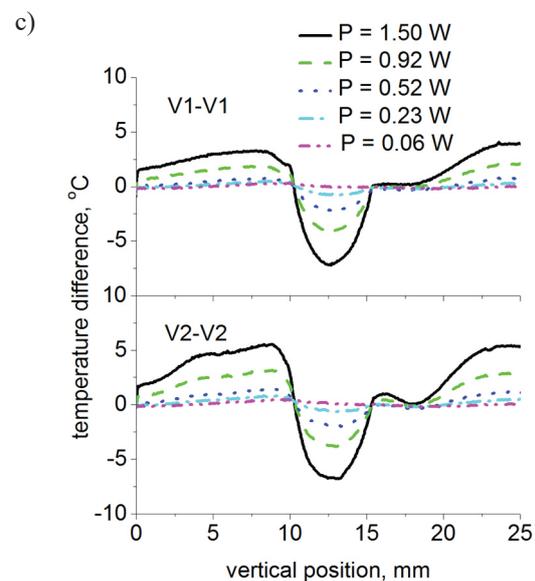
Fig. 6. Results of differential thermal measurements of graphene sample with intentionally introduced discontinuities. a) Differential thermal image for sample biased with $U = 50$ V (the position of scratches is marked with yellow dotted lines); b, c) horizontal and vertical cross-sections at marked positions, respectively.

To better evaluate the effect of mechanical defects on the thermal distributions, differential thermal images were calculated using thermographic camera software. These images illustrate how the thermal images of pristine sample changed due to mechanical modification of the sample. For this purpose, thermal images of pristine sample were inserted as reference images for the maps of the intentionally scratched sample (both reference and test maps were registered at the same bias level). An example of the resulting differential image for $U = 50$ V is shown in Fig. 6a. At horizontal cross-sections H1-H1 and H2-H2 (Fig. 6b), local maxima at the positions of scratch tips are clearly visible. In comparison, temperature decrease along the scratches is illustrated at vertical cross-sections V1-V1 and V2-V2 in Fig. 6c.
